Questions from the Community to EPA to be presented at the September 2019 NGPCCC

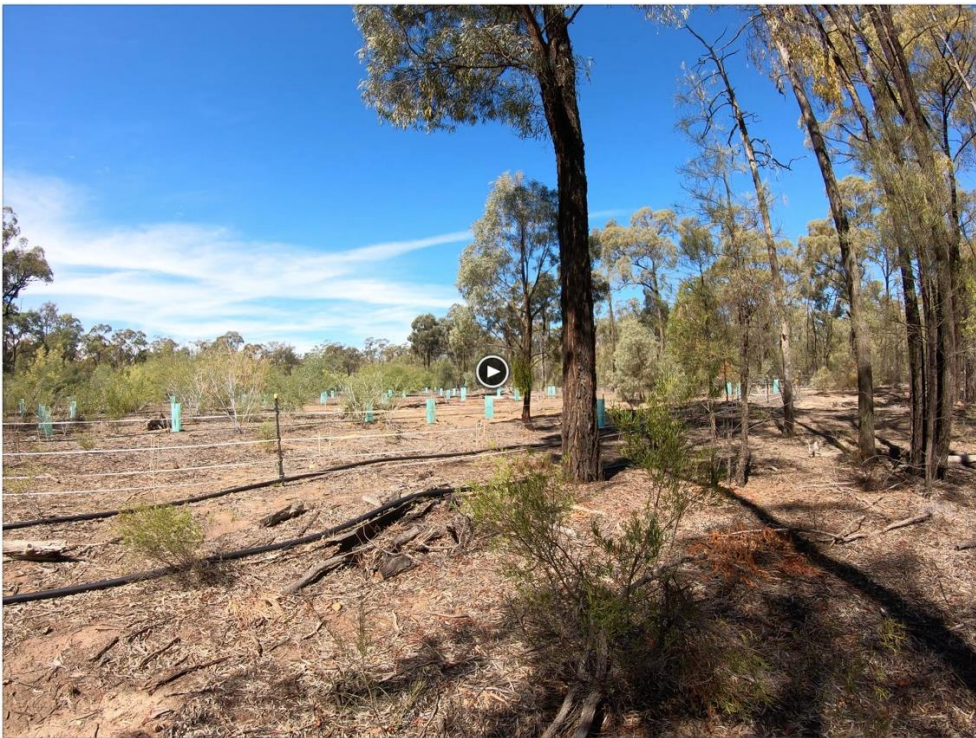
1. Bohena 6: GPS Location: 30°32'12.52"S 149°37'16.02"E
2. Bohena 5: GPS Location: 30°32'12.22"S 149°36'0.46"E
3. Bohena 3: GPS Location: 30°32'44.28"S 149°36'38.24"E

Above: Bohena 6 – mulch has flowed across and off the site leaving the interior of the site bare

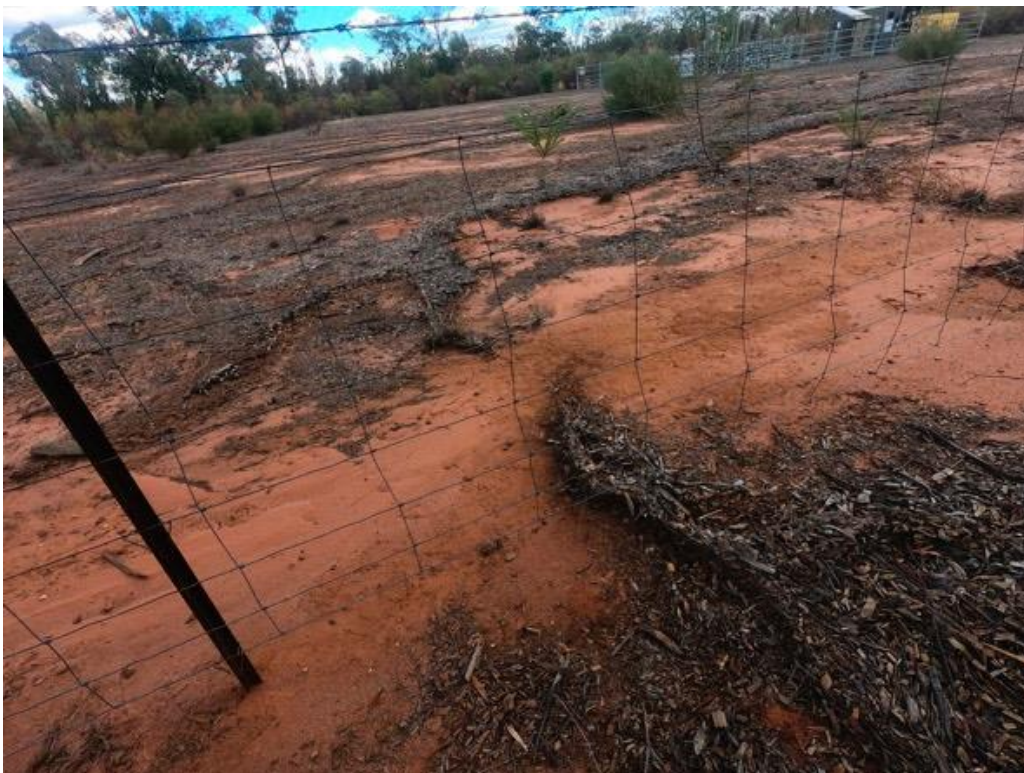
Figure 1 BW 22 mulch leaving lease area

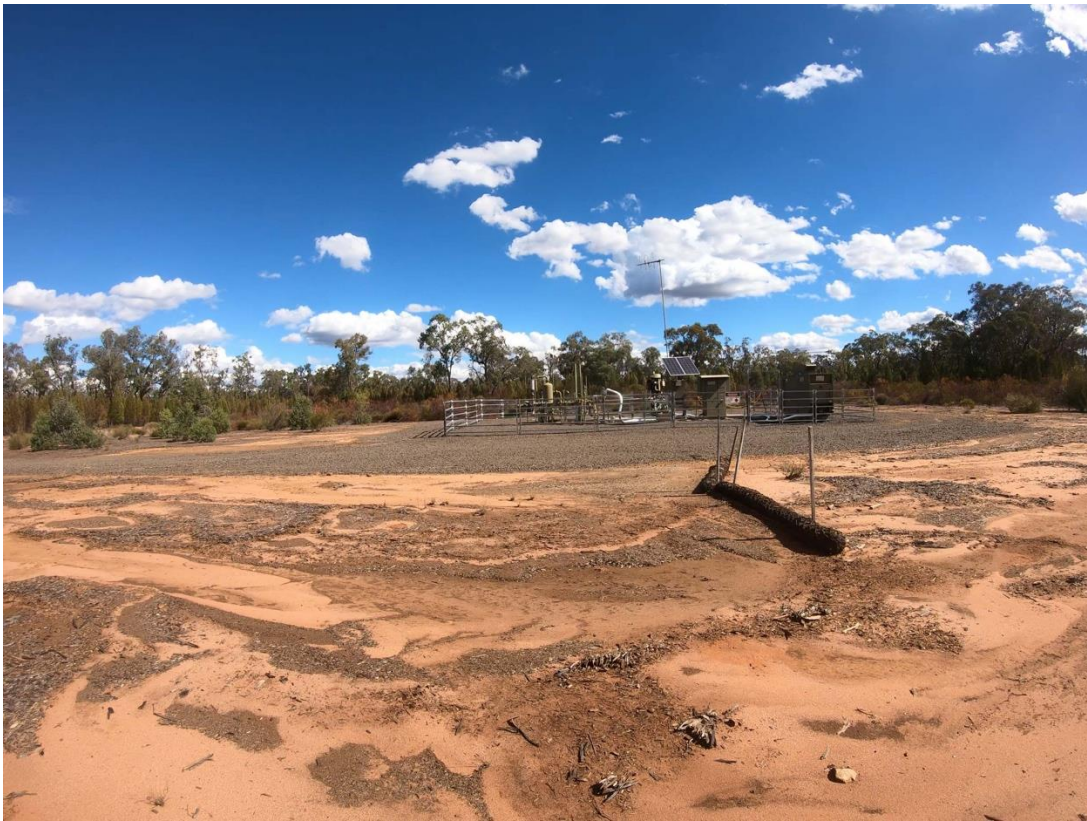
4. Bibblewindi West wells:
General GPS Location: 30°37'27.89"S 149°36'21.80"E (All well pads visited in this series of wells had run off issues. Bunding where installed appearing to have failed in mitigating run off (BW24).

Above: Bibblewindi 24 – coir log is failing to mitigate erosion and flow of material across the site

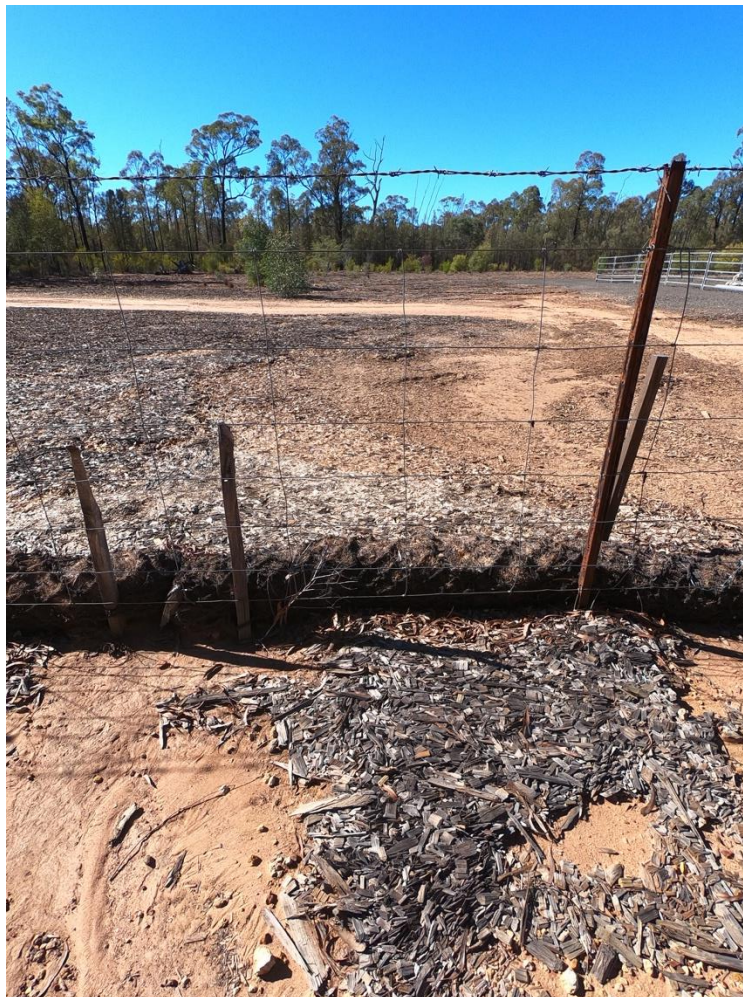
5. Bibblewindi East wells:
BW12: GPS Location: 30°39'57.66"S 149°38'56.96"E (Bunding/mulch/woodchip issue)
6. BW13: GPS Location: 30°39'46.85"S 149°39'5.26"E (mulch/woodchip issue)

Above: Bibblewindi 12 – coir log is failing to mitigate erosion and flow of material across the site

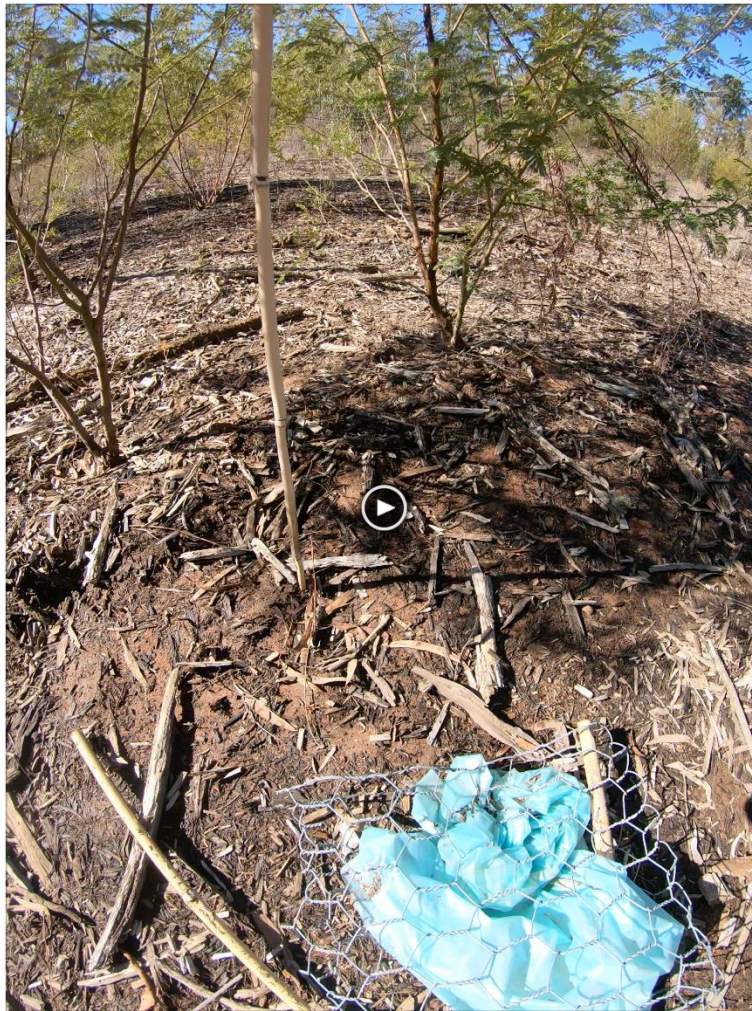
Above: Bohena 3 – Example of material outside of enclosure, the seedling has died but the wire, plastic & bamboo remain

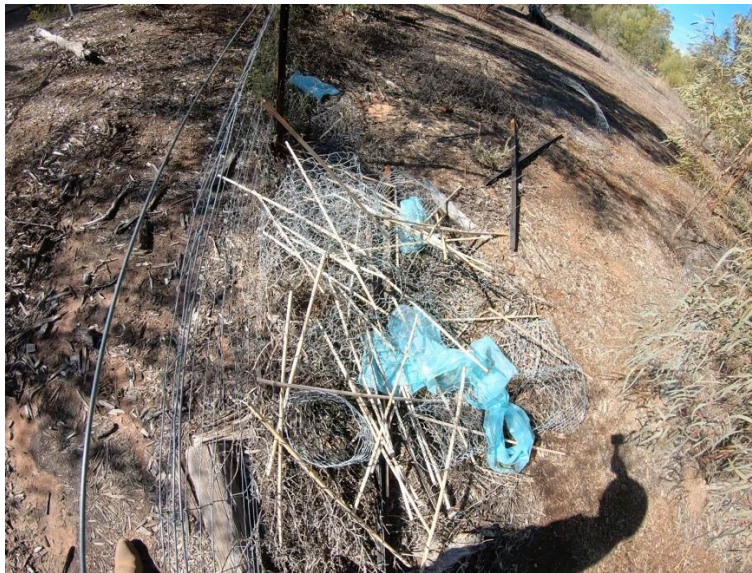
Above: Bohena 3 – abandoned material inside of enclosure
