Attachment 1

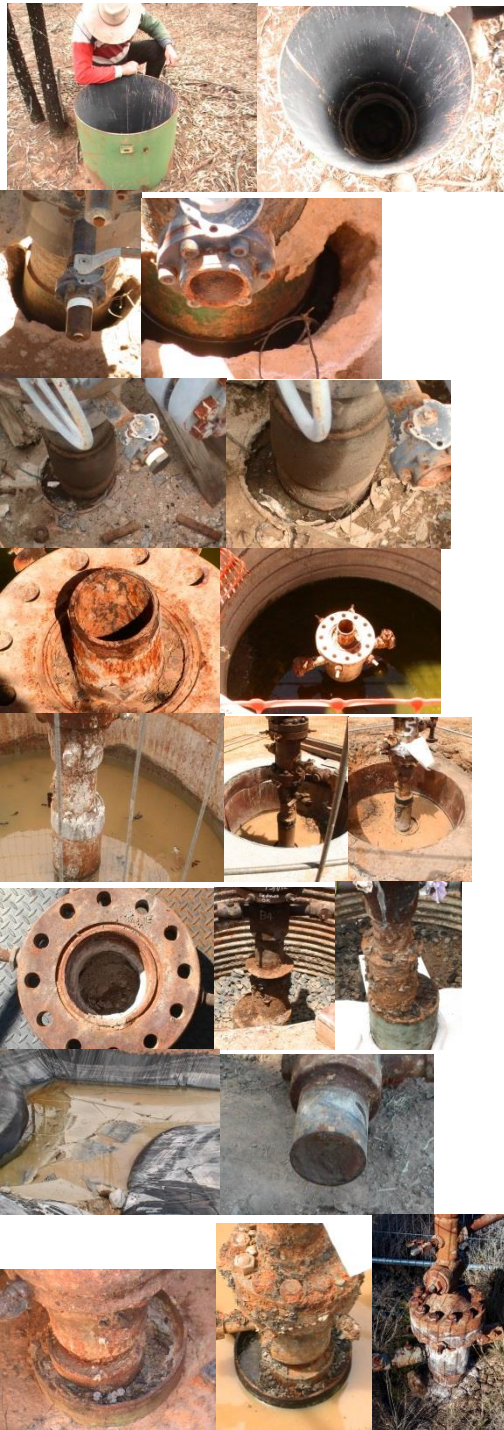
Dewhurst 10 + Video
 This shows the lack of cement between the two casings at the very top where it should not be.
 The disturbing factor here is it looks like there may have been a better cement seal (by the tongue of cement on the inner casing).
 So what happened, did the cement weaken off due to being passed through water and eventually eroded away. Note water in between casings.
 What ever the reason this is a perfect example why the public do not trust the so called Well Integrity Policy or the CAS Industry to do the correct thing.

This is AT THE Very Top OF THE Well. So all on the conditions underground.
