COMPLIANCE AUDIT

Leewood Ponds Water Management Facility

Santos NSW Pty Ltd

September 2015
Version 1

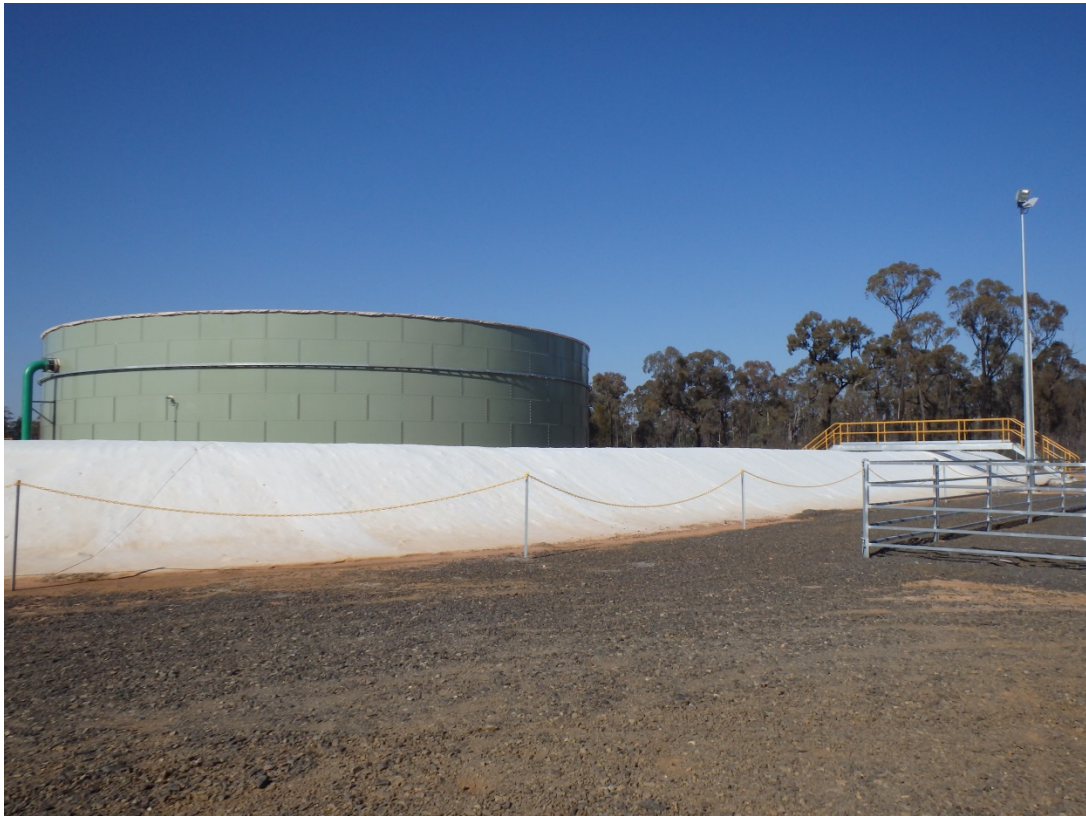
Plate 1 – 5ML tank at the Bibblewindi Facilities Area

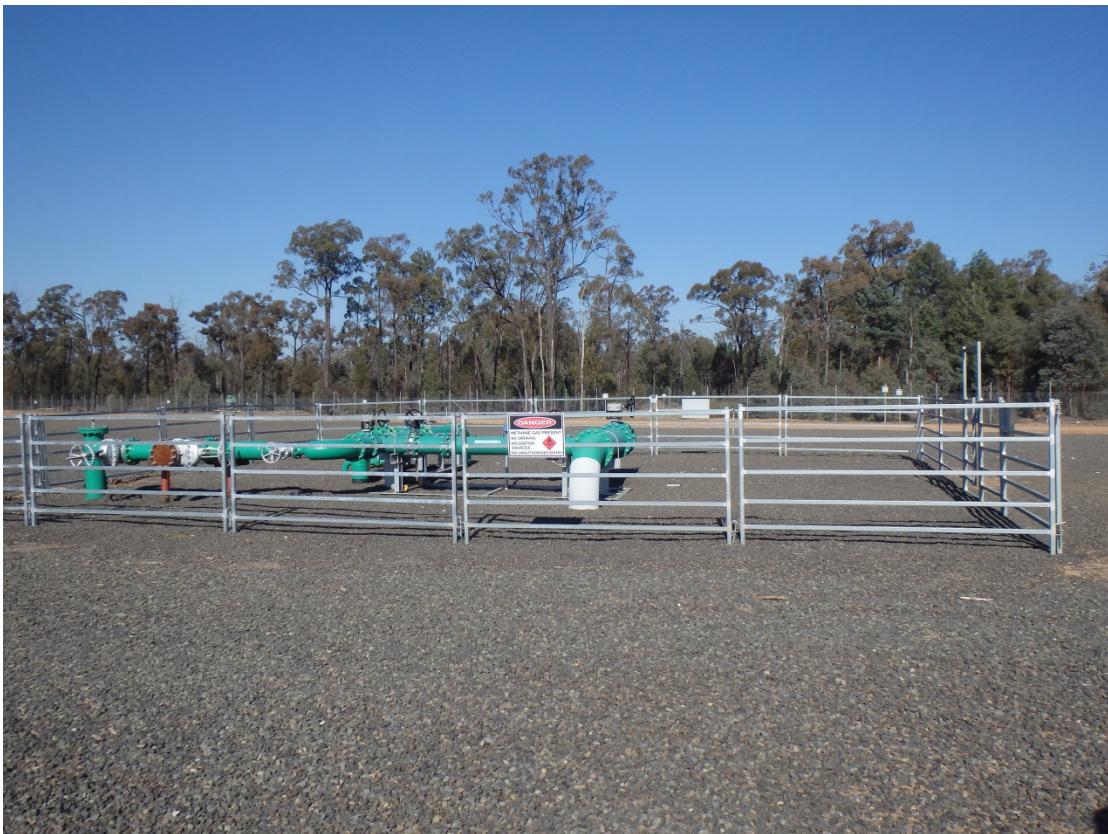
Plate 2 – Bibblewindi inlet manifold and associated pipework

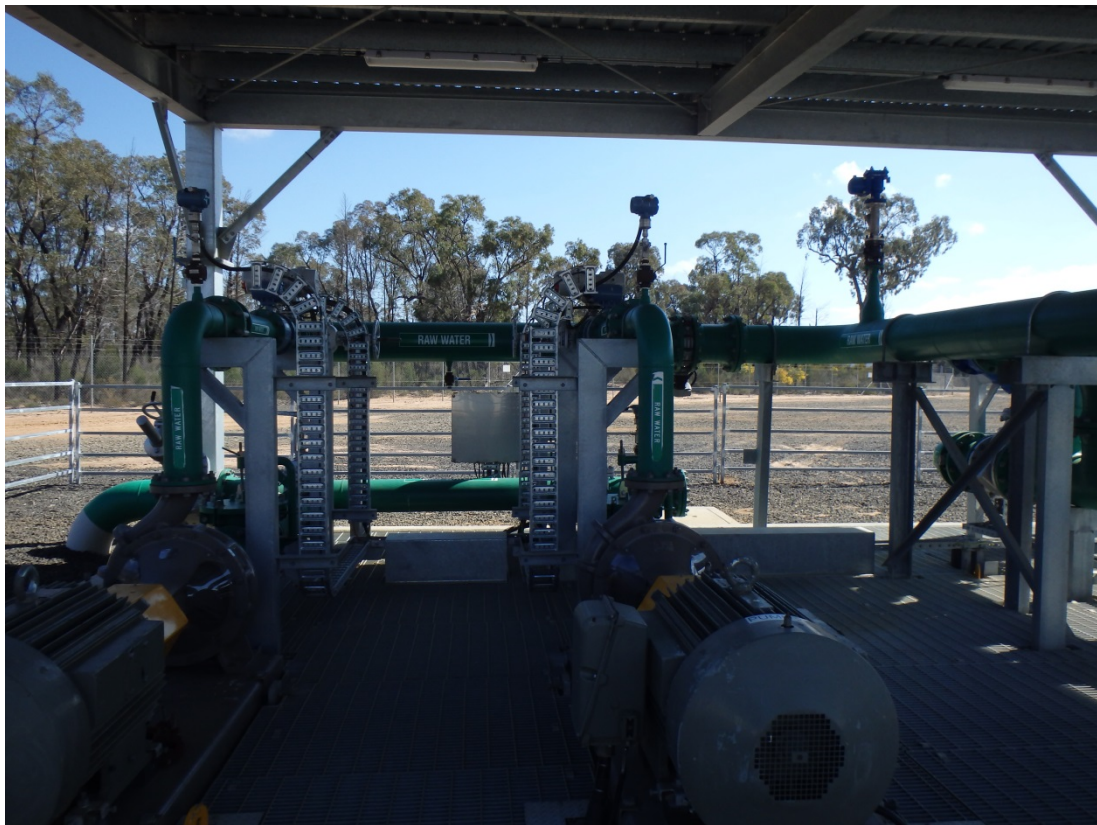
Plate 3 – Biblewindi outlet manifold, associated pumps, pipework and metering equipment

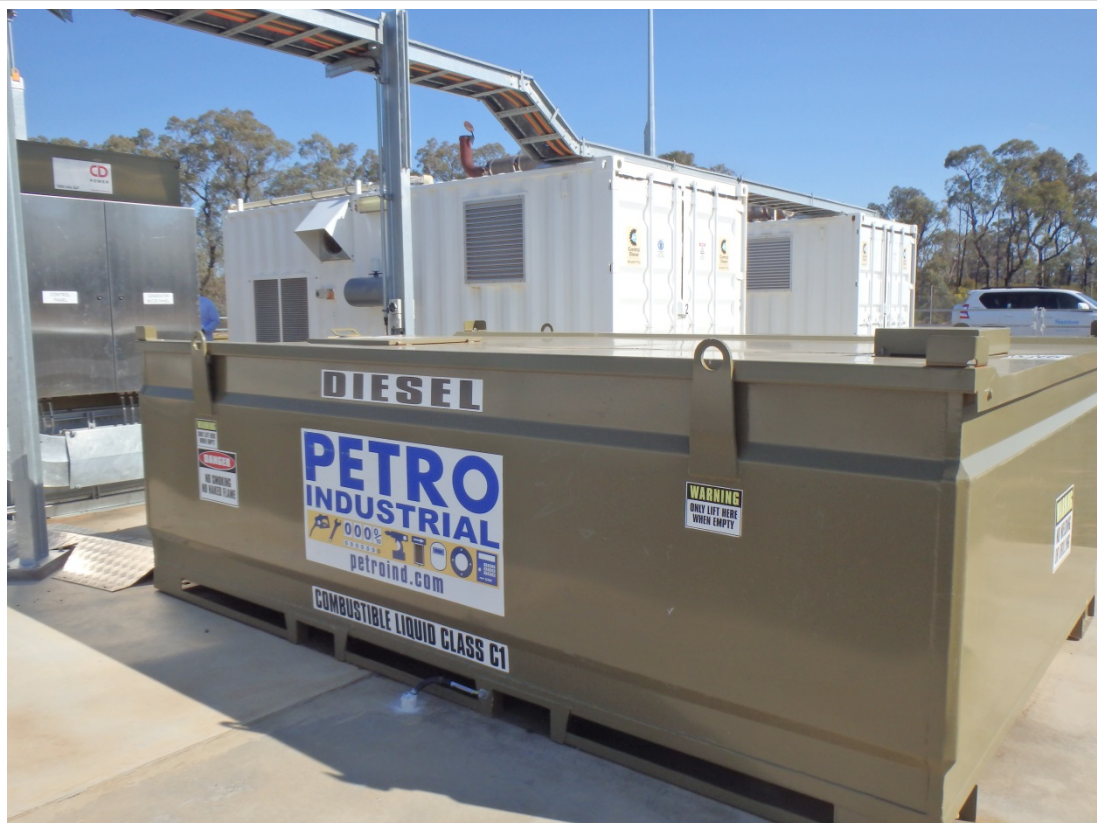
Plate 4 – Biblewindi gas fired engines and backup diesel generator

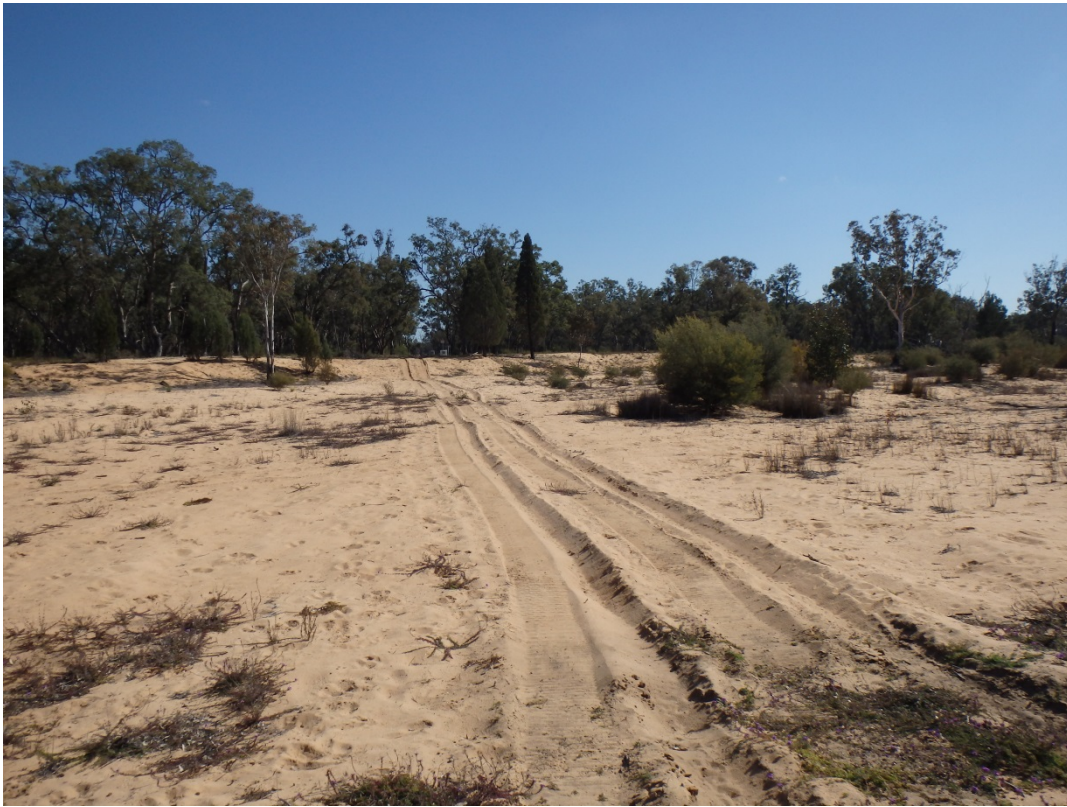
Plate 5 – Bohena Creek crossing along the flow line route

Bank stabilisation measures will be employed at Bohena Creek during flowline installation and the bank will be reinstated immediately following construction.	Compliant	No issues were observed in the creek at the crossing site and the banks had been rehabilitated.
	With the exception of the Newell Highway crossing and where the flowline reaches Bibblewindi, flowline installation works are to occur only within the existing right of way. Vegetation removal along these areas of the right of way will only involve slashing of grasses and disturbance associated with ripping and ploughing, or trenching if necessary.	Compliant	Inspection of the flow line route confirmed that works had been confined to the existing right of way. No significant vegetation clearing appears to have been undertaken.
	The additional area required outside the cleared right of way at the Newell Highway crossing is to be kept to a minimum and no greater than 20m x 30m. The additional work area is to be clearly marked and no works are to occur outside this area.	Compliant	Clearing observed at the Newell Highway crossing site was not excessive. Santos advised that the construction contractor had made use of an already cleared forestry stockpile site to minimise clearing. Rehabilitation works had been undertaken at the crossing site.

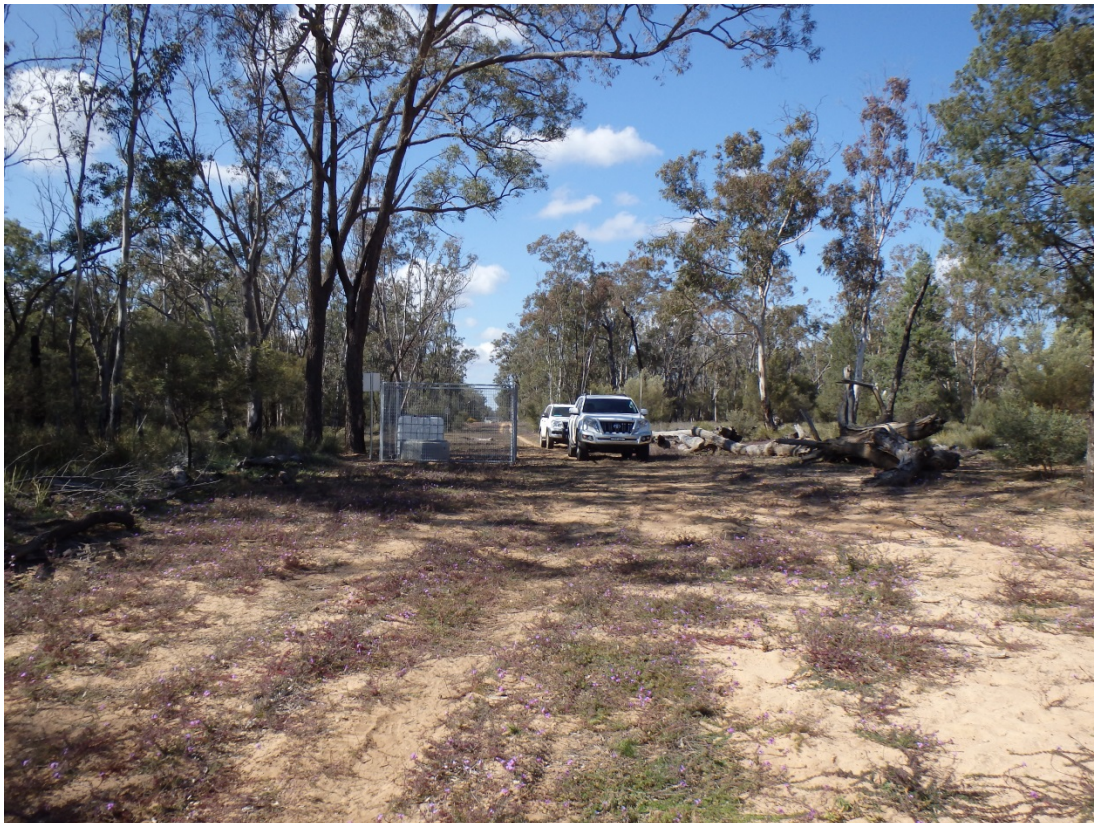
Plate 6 – Flow line route heading from Bohena Creek to Bibblewindi – note the fenced area containing a riser vent along the flow line

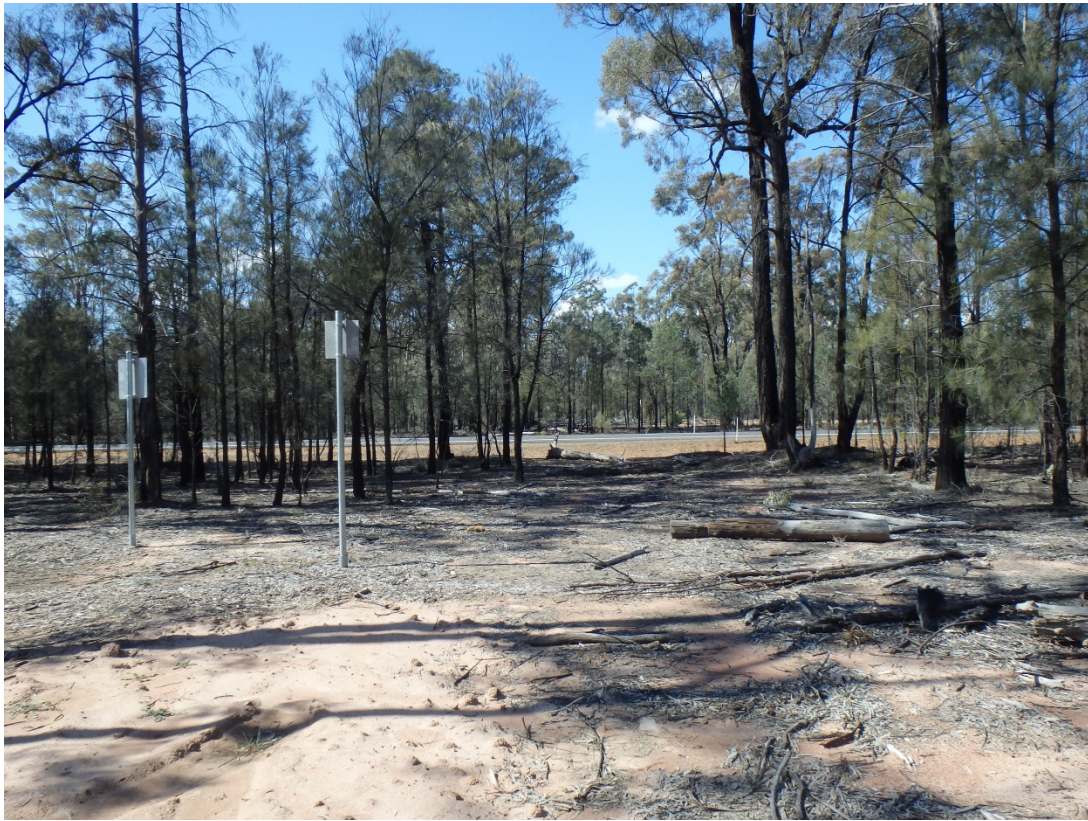
Plate 7 – Newell Highway pipeline crossing site (note pipeline signs indicating presence of pipelines)

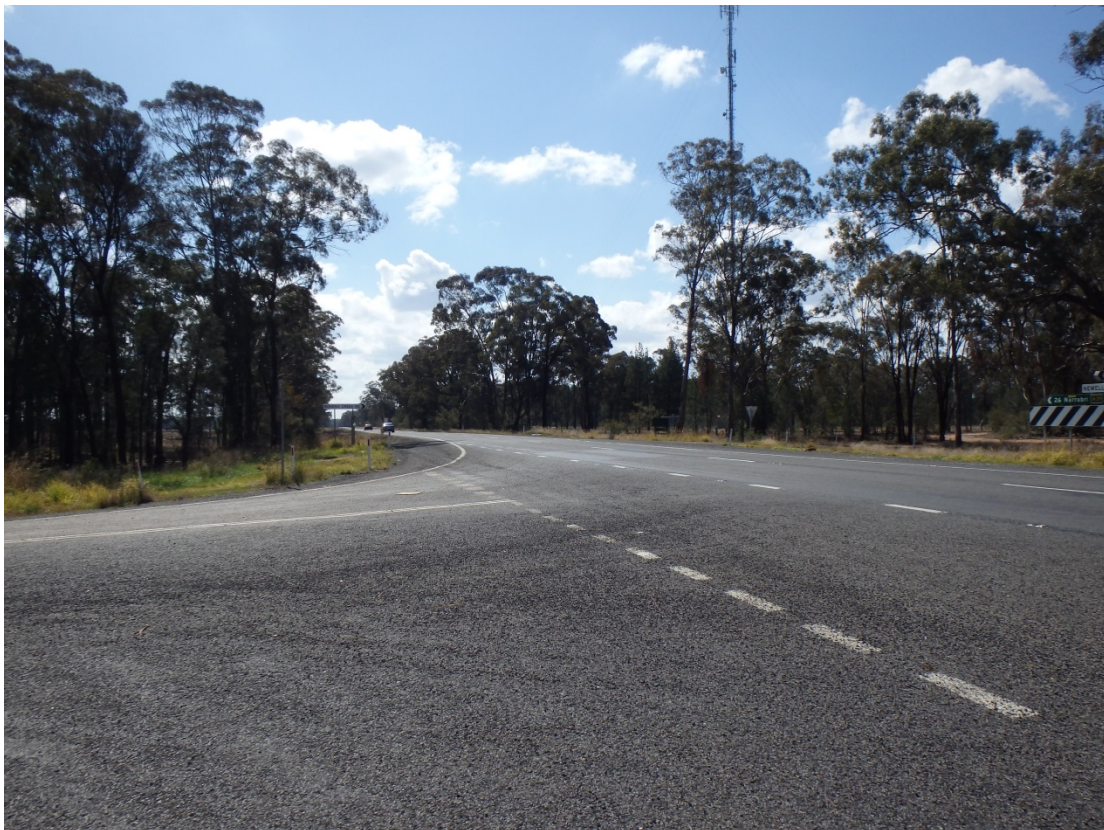
Plate 8 – Newell Highway/Old Mill Road intersection upgrade

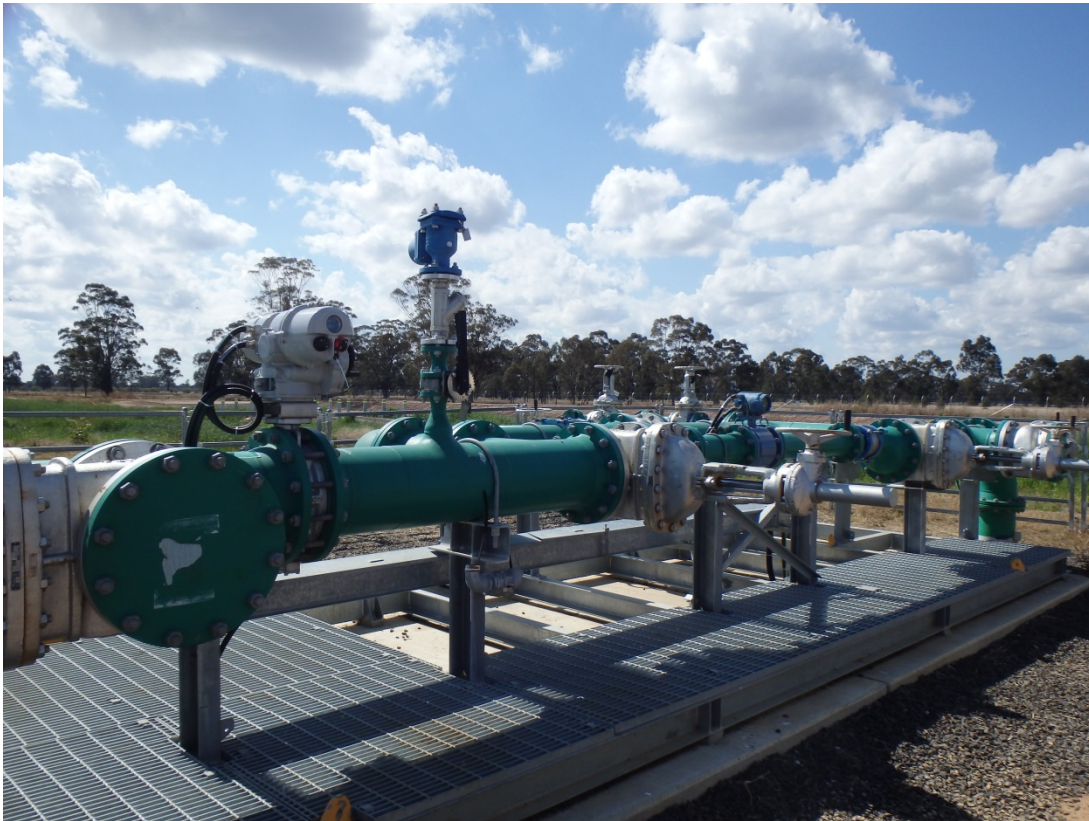
- Leewood inlet manifolds and associated pumps and metering equipment (**Plate 9**)
- Leak detection monitoring bores around the perimeter of the ponds
- Nested monitoring bores at the perimeter of the Leewood property

Plate 9 – Leewood inlet manifold and associated pumps and metering equipment

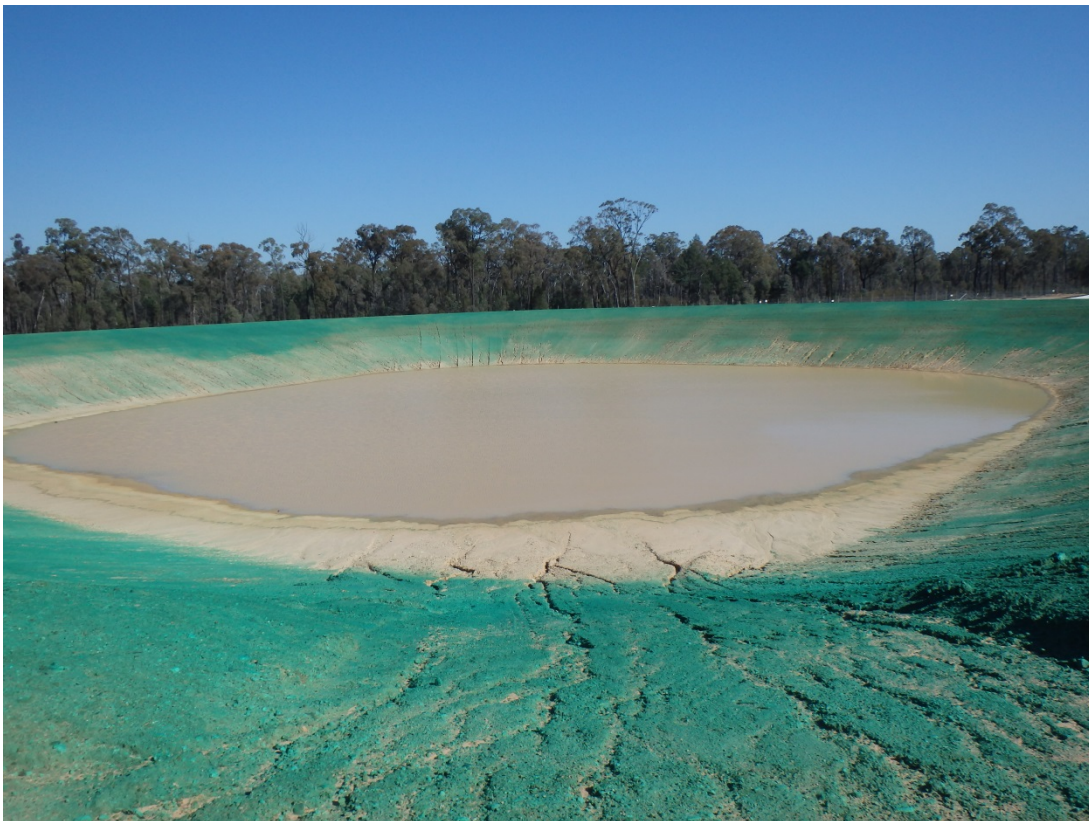
It was also confirmed that controls identified on the Erosion and Sediment Control Plan – Bibblewindi Facilities Area (SWMP-BFA-PR-0003, Revision 3, dated 20/4/2015) had also been implemented in the field. It was noted that, despite the polymer product applied to the inside batters of Pond 2 at Bibblewindi, there was evidence of erosion restarting, indicating that the polymer product may need to be reapplied (refer to **Plate 10**).

Plate 10 – Polymer product sprayed on pond batters at Bibblewindi Pond 2
