Santos

Rehabilitation Progress Update
- Project Overview

14 November 2012

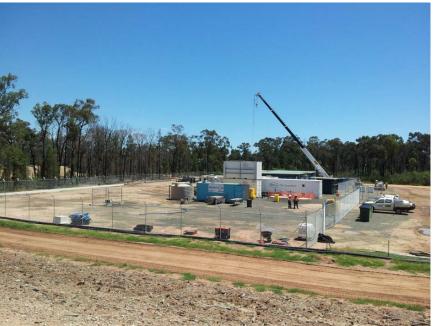
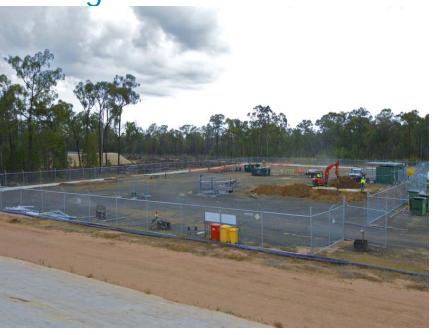
Bibblewindi Water Treatment Plant

- Following Santos decision to shut down the plant in December and evidence of the spill in January, a review of the water treatment facility:
 - the reverse osmosis plant had a history of operational issues
 - the plant and ponds were not constructed to Santos standards and Santos has concerns with the integrity of the facilities
- It has been decided to construct a new central water treatment facility to manage all of the water from the proposed gas exploration development.
- An execution plan was prepared to properly shut down the Bibblewindi facility, and the removal of the plant began in October 2012.

- Removal of the water treatment facility began in October 2012
- Expected date of completion is December 2013
