Information Request Response

Reference:	March 2015 CCC Meeting 001
Subject:	Tony Pickard Photographs
Request date:	20 March 2015 (Narrabri CCC Secretariat)
Requested by:	Tony Pickard
nequested by	Member
	Representing: People for the Plains

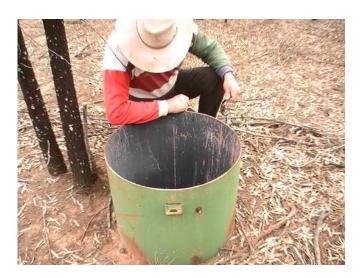
Photographs of "Old Oil Well"

The photographs labelled "Old Oil Well" are not of an old oil well. This item is unrelated to gas exploration and appraisal activities in the Narrabri area by either Santos or previous exploration licence holders.

The photographs are of a component of the Sydney University Giant Airshower Recorder (SUGAR) array. The liquid scintillation detectors consist of what presents as a 44 gallon drum half buried in the ground. The shaft of the liquid scintillation detector may reach up to 5 metres below the ground, before opening into a wider chamber underneath.

The SUGAR array was established by the University of Sydney's School of Physics in the Pilliga Forest, and operated between 1968 and 1979. The array consisted of 54 stations dotted around the Pilliga Forest, with each station consisting of pairs of large liquid scintillation detectors (pits filled with fluid) separated by 50 metres.

The entire Sydney University Giant Air-shower Recorder covered an area of 100 km² (Sydney University Physics Department 2008) although the precise locations of the stations throughout the Pilliga are not available.

The SUGAR project was developed to measure showers resulting from cosmic ray particles of the highest known energy. Each station operated in an autonomous manner with solar power units and received their timing information via radio receivers (Brownlee et al 1968: 68). At this stage it is unknown how many of these stations remain in situ in the area.

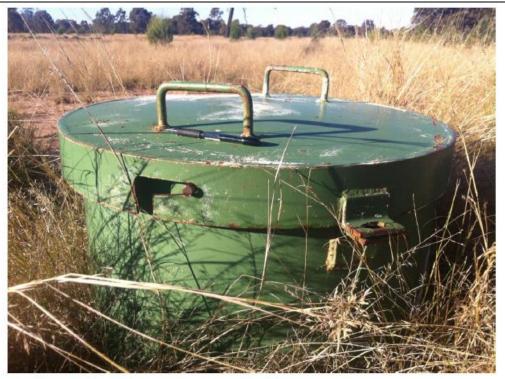
Photograph of another SUGAR Pit within the Narrabri area for reference:

SUGAR Pit A. When the lid was removed, the structure revealed a tunnel of approximately five metres deep which opened into a cavity at the bottom.

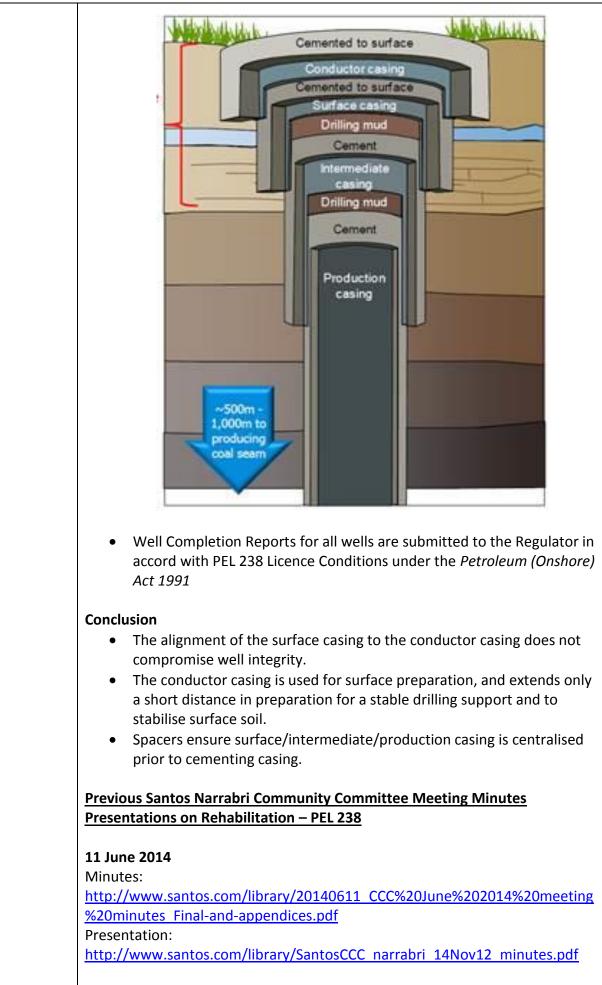
- Conductor casing is installed on the drill pad in preparation for the drilling rig, with casing usually installed to 6 – 12 metre depth depending on the type of soil at the pad site, type of rig being used for drilling, etc.
- The conductor casing is the widest in diameter and serves as a support during drilling operations, to flow back returns during drilling and cementing of the surface casing, and to prevent collapse of the loose soil from the surface. Conductor casing is usually from 14" to 30" in diameter. The conductor casing is usually installed to a depth of between 6 and 12 metres.
- Spacers are used to ensure that well casing for the surface casing, intermediate casing and production casing is centralised prior to the casing being cemented. Diagram below illustrates the different casing types.

• Mr Pickard raised a point about casing not aligned centrally to the conductor casing.
