## Narrabri Coal Seam Gas Utilisation Project

**Approval 07-0023**

**Wilga Park Power Station and Pipeline**

**Santos**

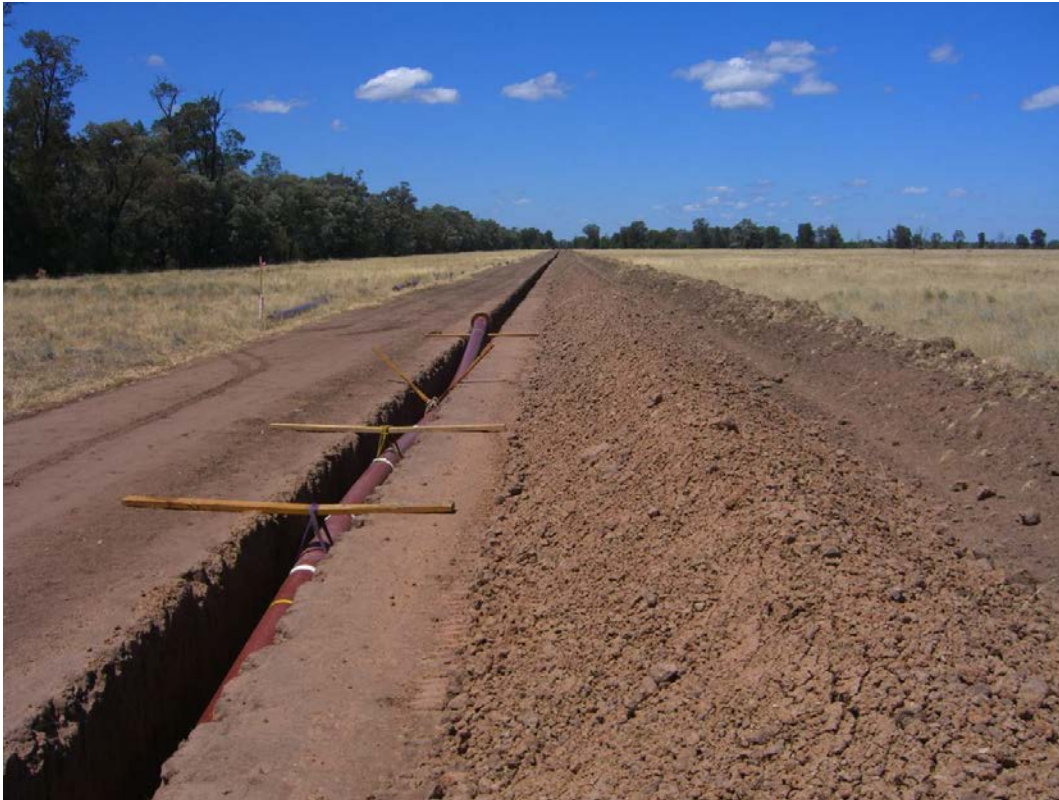
- Careful separation of topsoil and trench spoil being achieved;
- Reduced working of ROW and vegetation management is being implemented; and

Figure 2 Construction ROW showing topsoil stripping and separation.

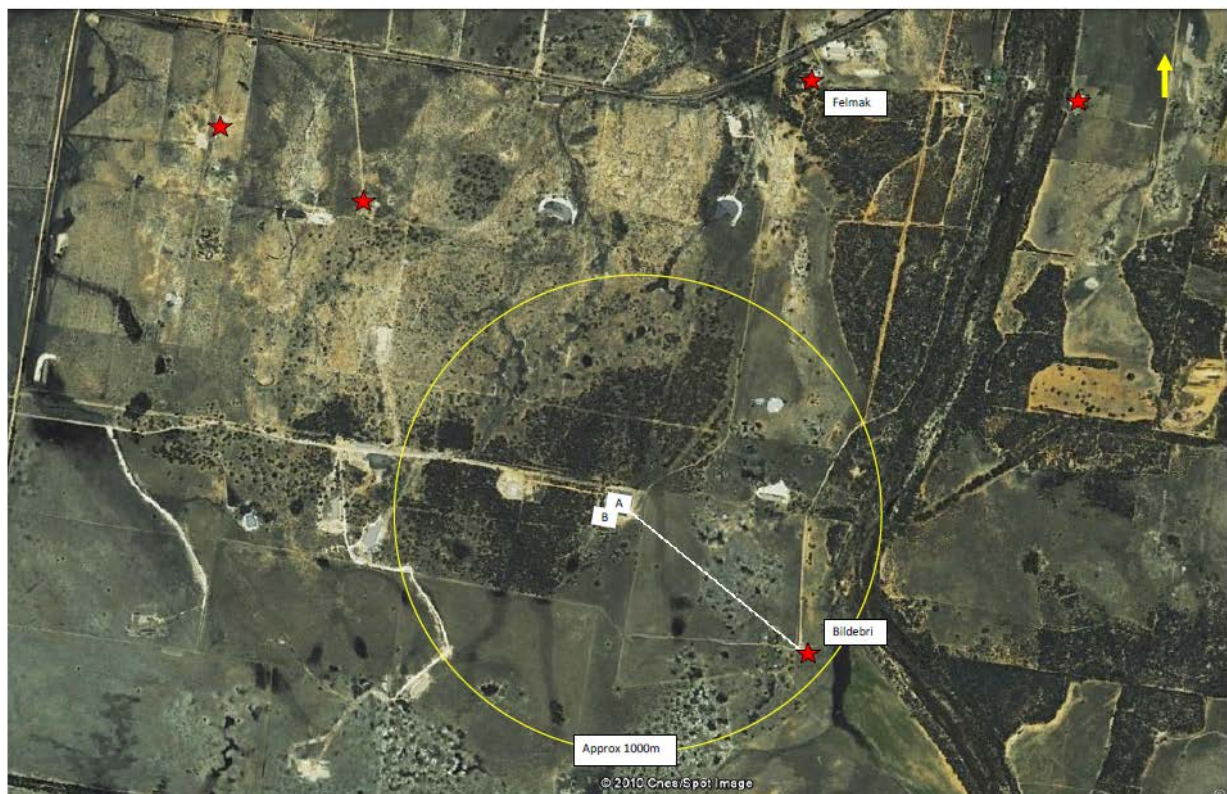
In mid-2010, neighbouring residents, Mr and Mrs Hatch (Bildebri) contacted the previous operator regarding concerns over the potential of noise impacts on their residence. The Bildebri residence is located within 1km of WPPS. ESG made contact with the landholders on a number of occasions to resolve any concerns that were raised. As no official complaint was submitted and the threshold monitoring levels of the approval had not been triggered, the operator was not required to respond to the landholders' concerns. However ESG voluntarily responded to the issues raised by Mr and Mrs Hatch by engaging noise consultants to investigate the potential for noise levels to be reduced in the current operating generators and to implement these mitigations on the three currently uncommissioned units.

Figure 3: Location of the Bildebri residence in relation to the WPPS (A – original power station; B – WPPS expansion)

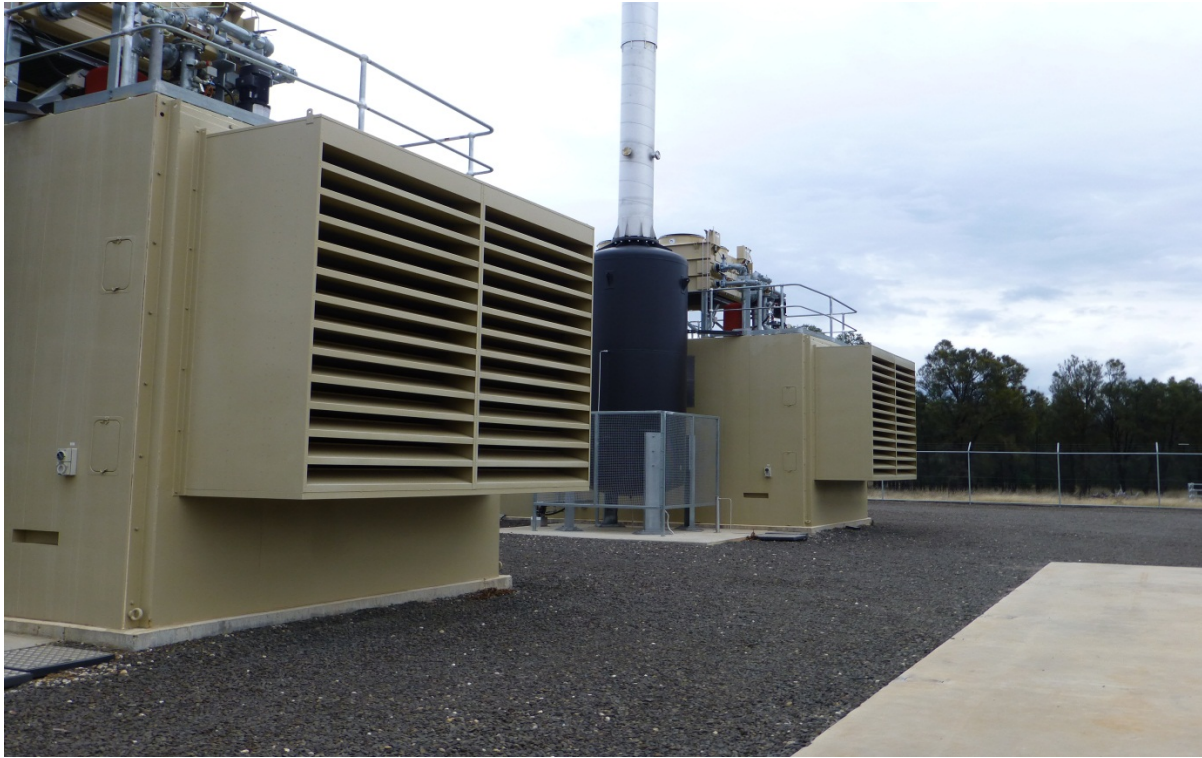
In September 2010, Noise Measurement Services Pty Ltd was engaged to conduct noise modelling on the commissioned 3 MW unit. Elevated results indicated that there was a potential point source issue with the cooling tower fans. Attenuation measures were recommended by the consultant and adopted by ESG in 2011 following installation of VSD operated ventilation fans.

Figure 4 Noise Attenuated Intake on 3 megawatt units.

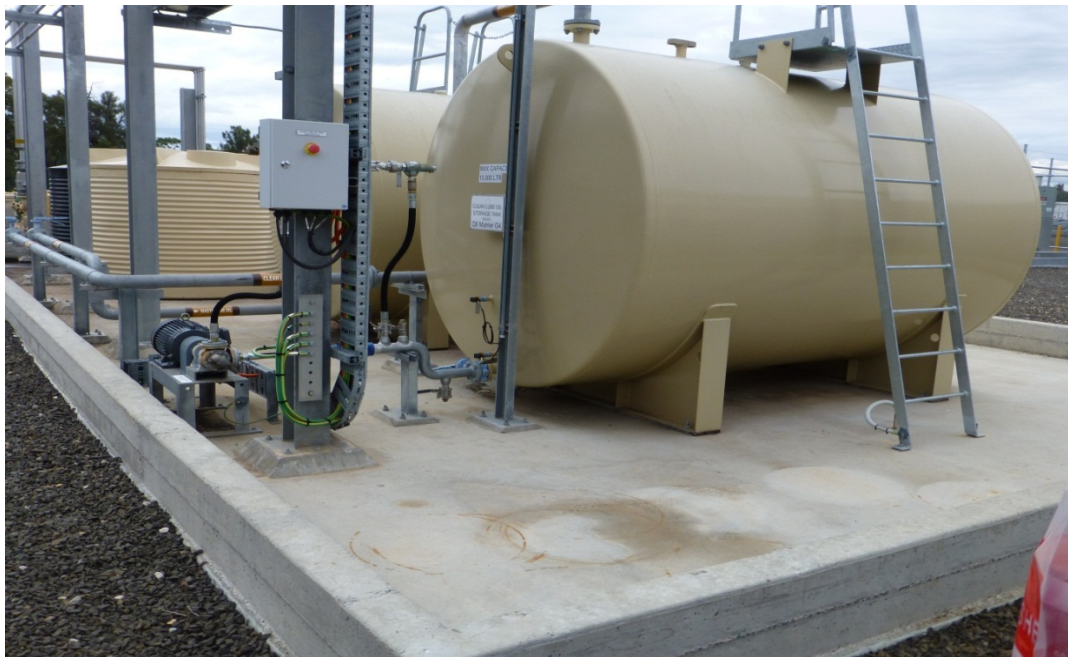
In response to the internal corporate audit undertaken in 2011/2012, a bund register was created to satisfy the requirements of Santos' EHS02 Underground Storage Tanks (USTs) and Bunds. This standard requires each bund to be assessed for suitability for use, measurements to be noted, status to be assessed (i.e. damaged, in use, not in use etc.) and for this information to be stored in one central location. The EHS02 bund register for NSW is currently stored on the Santos intranet file sharing program known as 'SharePoint'. The

Figure 6 Bunding at WPPS oil storage area
