# Legacy Rehabilitation Project – Progress Update

Doug Main – Project Manager, Energy NSW

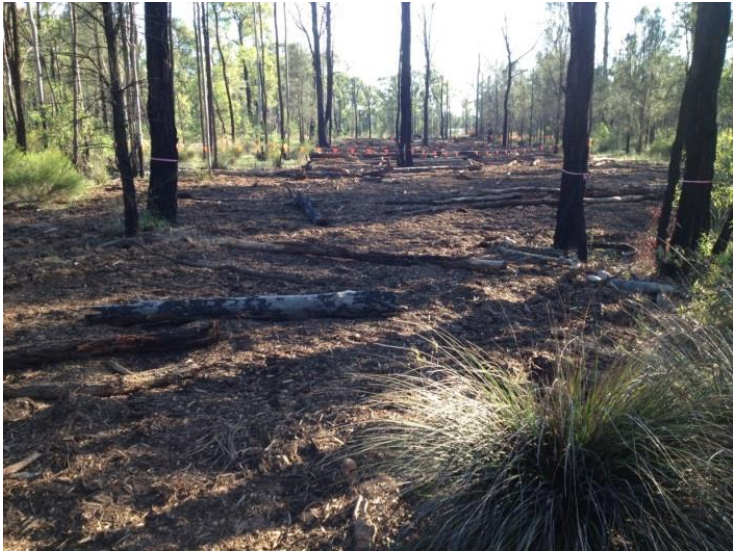
Biblewindi – after civil works

- ✓ • Removal of dead vegetation (safety concerns) – used later for soil stabilisation and to create habitat
- ✓ • Removal of heavily impacted soil
- ✓ • Earthworks to improve drainage and site contours
- ✓ • In-situ chemical treatment of impacted and affected soils (gypsum and sulphur)
- ✓ • Respread retained topsoil
- ✓ • Addition of organics to soil
- ✓ • Respread retained timber
- ✓ • Irrigation of soil to assist chemical processes
- ✓ • Assisted revegetation
- ✓ • Ongoing monitoring

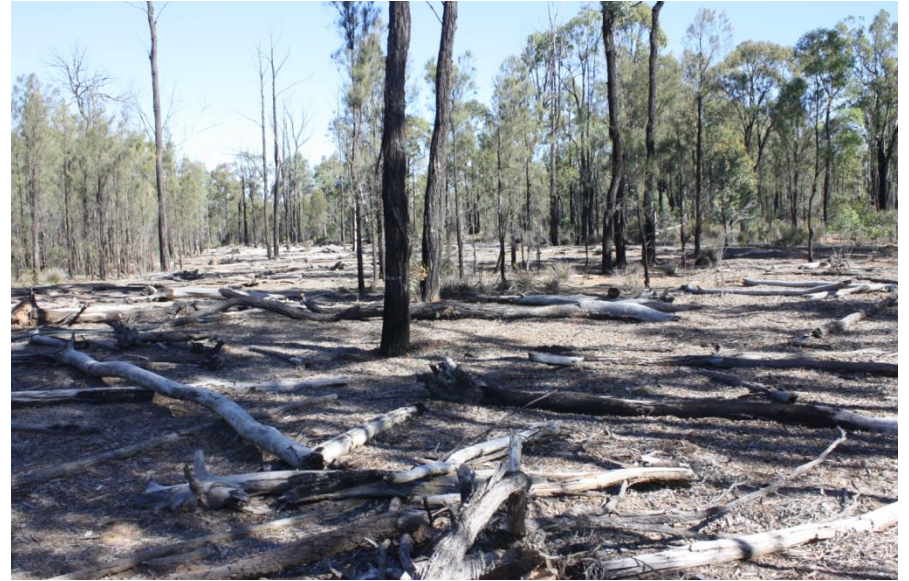
Biblewindi – 11 June 2014

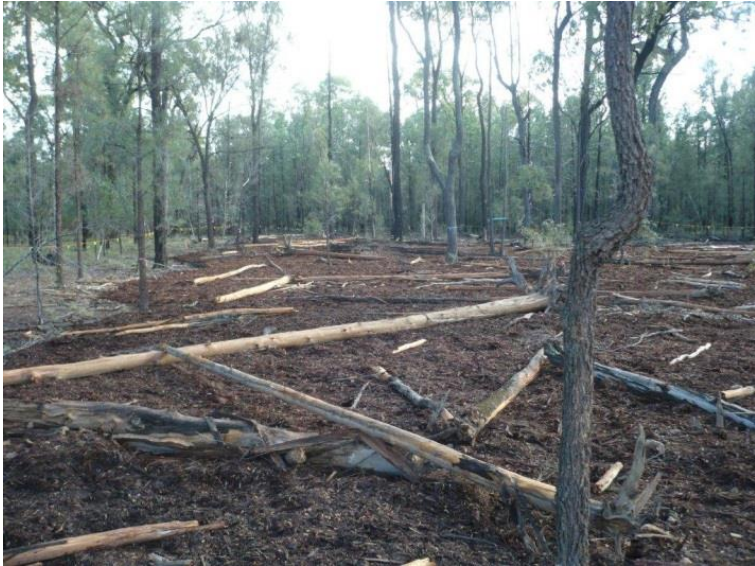
Bohena 7 – after civil works  
23 February 2013

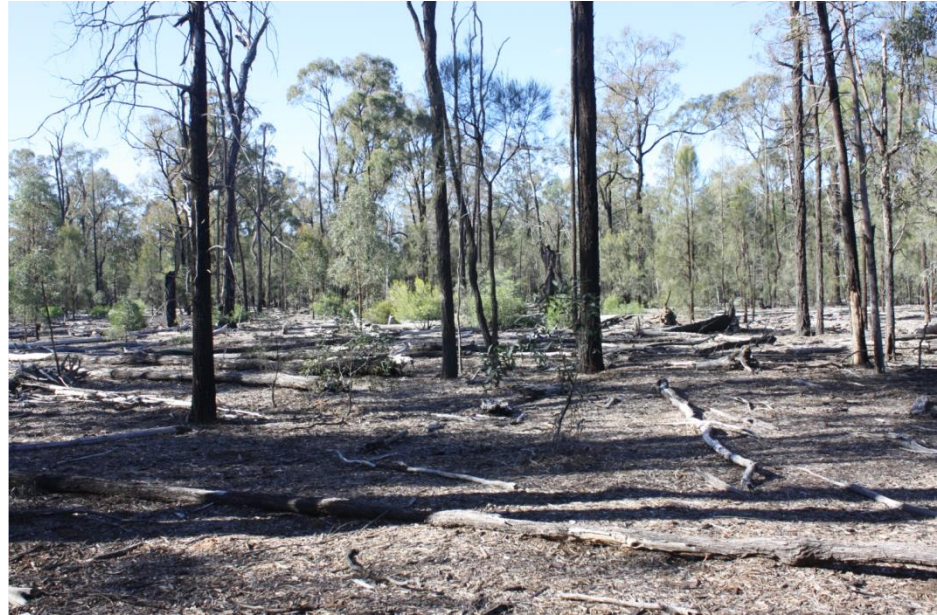
Bohena 7 – 11 June 2014
