NARRABRI CCC MONTHLY UPDATE

MARCH 2016

The following is a monthly update for the Narrabri CCC regarding activities undertaken by the NSW Environment Protection Authority (EPA) relating to PEL 238 (Narrabri Gas Project). It includes both activities undertaken relating to Environment Protection Licence 20350 and the EPA's functions conducted under the NSW Gas Plan.

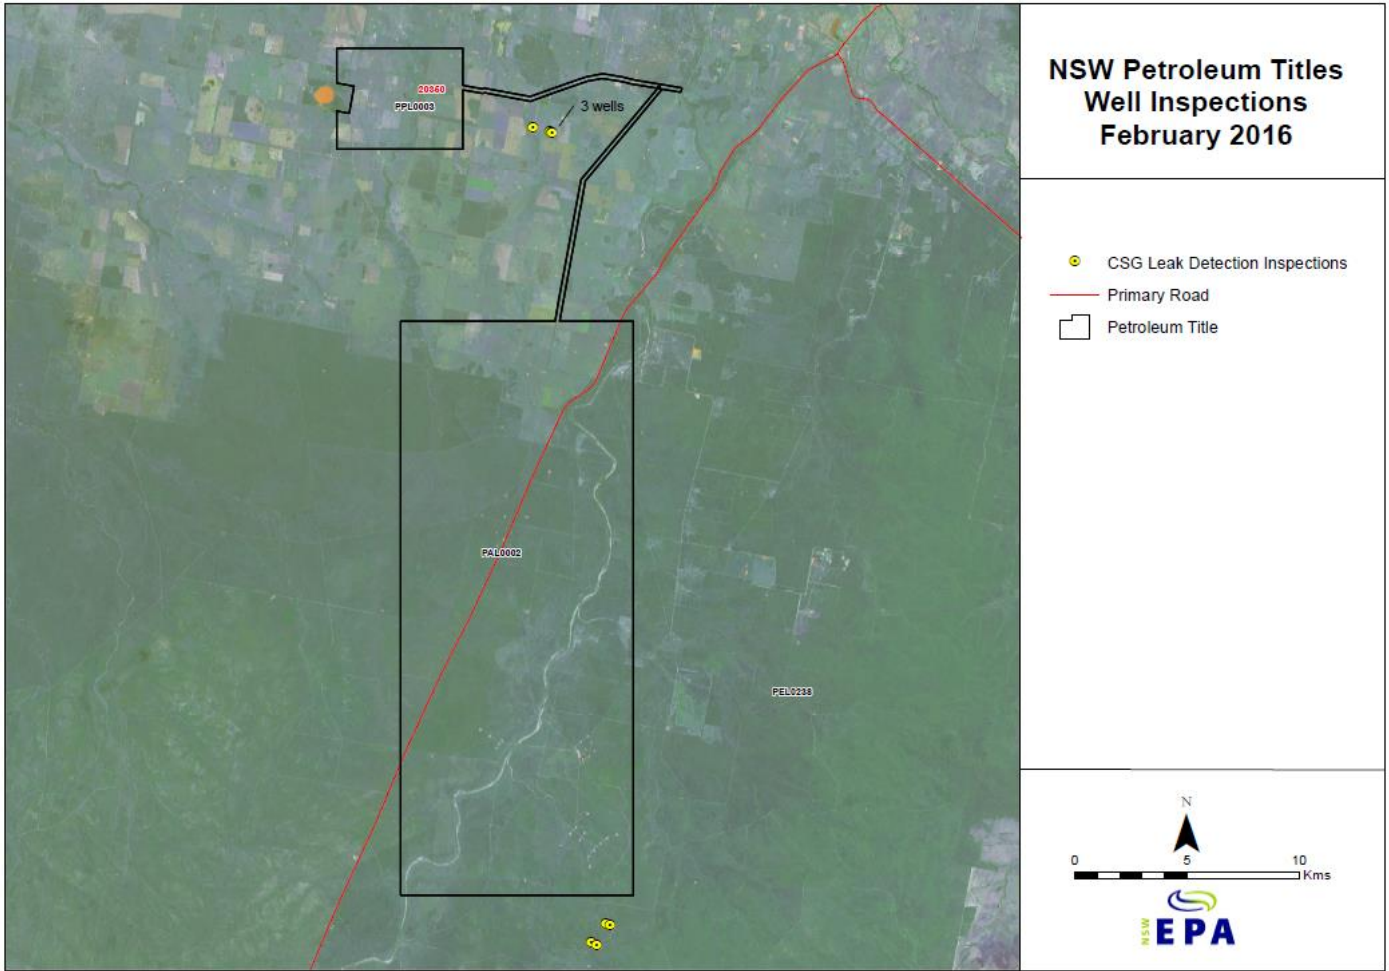
Narrabri LDAR Inspections – February 2016

INSPECTIONS – Leak Detection and Repair (LDAR) and Hydrogen Sulphide (H₂S)				
SITE ID	DATE INSPECTED	REASON	ACTION/OUTCOME	STATUS
Tintsville 2H, 3H, 4H & 6 Narrabri Gas Field	9/2/2016	Undertake Leak detection monitoring	No reportable leaks detected	No H ₂ S detected
Dewhurst 26, 27, 28 & 29 south Pilot Narrabri Gas Field	10/2/2016	Undertake Leak detection monitoring	No reportable leaks detected	No H ₂ S detected.
