**Santos Limited, Wilga Park  
Emission Testing Report  
Report Number R012308**

Client Name: Santos Limited  
Report Number: R012308  
Date of Issue: 22 March 2022  
Attention: Abigail Kahi  
Address: Level 22, 32 Turbot Street  
Brisbane QLD 4000  
Testing Laboratory: Ektimo Pty Ltd, ABN 86 600 381 413

Ektimo was engaged by Santos Limited to perform emission testing from gas-fired engines situated at their Wilga Park plant.

The objectives of the project were to conduct a monitoring programme to quantify emissions from multiple discharge points to determine compliance with Santos Limited's Development Approval DA07-0023.

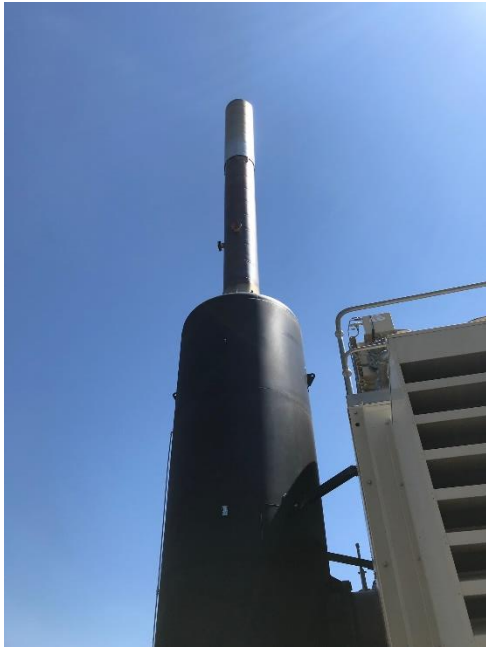
GO 1A, 2A, 3B, 4B, 5B, 6B

The sampling plane is deemed to be non-ideal due to the following reasons:

The sampling plane is too near to the upstream disturbance but is greater than or equal to 2D

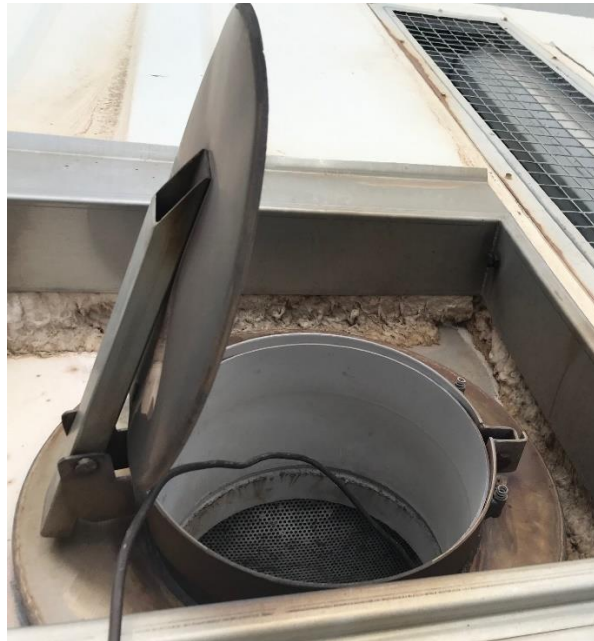
GO 3A, 5A, 6A

The sampling plane is deemed to be non-compliant due to the following reasons:

The downstream disturbance is <1D from the sampling plane

The upstream disturbance is <2D from the sampling plane

The stack or duct does not have the required number of access holes (ports)
