REPORT NUMBER R009780r

**Emission Testing Report
Santos Limited, Wilga Park**

Ektimo was engaged by Santos Limited to perform emission testing from gas-fired engines situated at their Wilga Park plant.

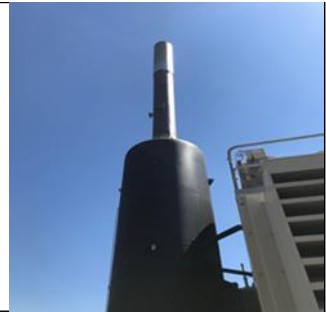
2.1 GO1A

Sampling plane dimensions	600 mm
Sampling plane area	0.283 m ²
Sampling port size, number	4" Flange (x2)
Access & height of ports	Elevated work platform 10 m
Duct orientation & shape	Vertical Circular
Downstream disturbance	Exit 8 D
Upstream disturbance	Change in diameter 3 D
No. traverses & points sampled	2 12
Sample plane compliance to AS4323.1	Compliant but non-ideal

The sampling plane is deemed to be non-ideal due to the following reasons:

The sampling plane is too near to the upstream disturbance but is greater than or equal to 2D

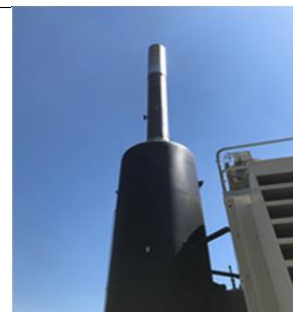
2.3 G05B

Sampling plane dimensions	600 mm
Sampling plane area	0.283 m ²
Sampling port size, number	4" Flange (x2)
Access & height of ports	Elevated work platform 10m
Duct orientation & shape	Vertical Circular
Downstream disturbance	Exit 8 D
Upstream disturbance	Change in diameter 3 D
No. traverses & points sampled	2 12
Sample plane compliance to AS4323.1	Compliant but non-ideal

The sampling plane is deemed to be non-ideal due to the following reasons:

The sampling plane is too near to the upstream disturbance but is greater than or equal to 2D

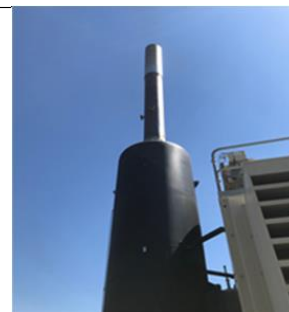
2.4 GO6B

Sampling plane dimensions	600 mm
Sampling plane area	0.283 m ²
Sampling port size, number	4" Flange (x2)
Access & height of ports	Elevated work platform 10m
Duct orientation & shape	Vertical Circular
Downstream disturbance	Exit 8 D
Upstream disturbance	Change in diameter 3 D
No. traverses & points sampled	2 12
Sample plane compliance to AS4323.1	Compliant but non-ideal

The sampling plane is deemed to be non-ideal due to the following reasons:

The sampling plane is too near to the upstream disturbance but is greater than or equal to 2D

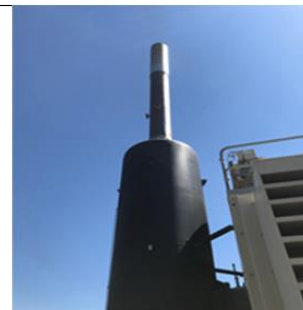
2.5 GO2A

Sampling plane dimensions	600 mm
Sampling plane area	0.283 m ²
Sampling port size, number	4" Flange (x2)
Access & height of ports	Elevated work platform 10m
Duct orientation & shape	Vertical Circular
Downstream disturbance	Exit 8 D
Upstream disturbance	Change in diameter 3 D
No. traverses & points sampled	2 12
Sample plane compliance to AS4323.1	Compliant but non-ideal

The sampling plane is deemed to be non-ideal due to the following reasons:

The sampling plane is too near to the upstream disturbance but is greater than or equal to 2D

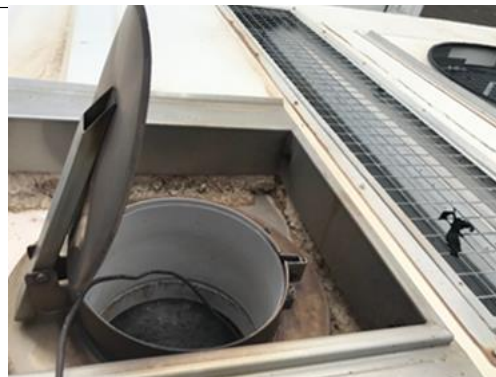
2.6 GO3A

Sampling plane dimensions	320 mm
Sampling plane area	0.0804 m ²
Sampling port size, number	Sampled at exit
Access & height of ports	Platform ladder 4 m
Duct orientation & shape	Vertical Circular
Downstream disturbance	Exit 0D
Upstream disturbance	Exit 0D
No. traverses & points sampled	2 8
Sample plane compliance to AS4323.1	Non-compliant

The sampling plane is deemed to be non-compliant due to the following reasons:

The downstream disturbance is <1D from the sampling plane

The upstream disturbance is <2D from the sampling plane

The stack or duct does not have the required number of access holes (ports)

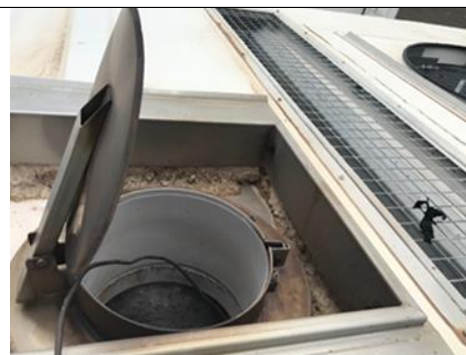
2.7 GO4A

Sampling plane dimensions	320 mm
Sampling plane area	0.0804 m ²
Sampling port size, number	Sampled at exit
Access & height of ports	Platform ladder 4 m
Duct orientation & shape	Vertical Circular
Downstream disturbance	Exit 0D
Upstream disturbance	Exit 0D
No. traverses & points sampled	2 8
Sample plane compliance to AS4323.1	Non-compliant

The sampling plane is deemed to be non-compliant due to the following reasons:

- The downstream disturbance is <1D from the sampling plane
- The upstream disturbance is <2D from the sampling plane
- The stack or duct does not have the required number of access holes (ports)

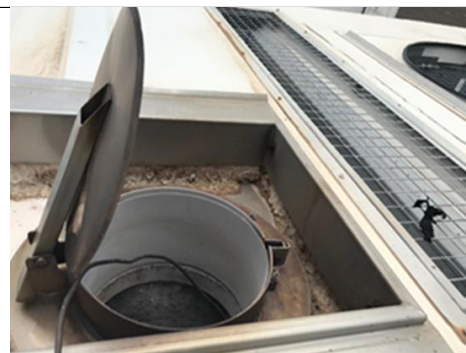
2.8 GO6A

Sampling plane dimensions	320 mm
Sampling plane area	0.0804 m ²
Sampling port size, number	Sampled at exit
Access & height of ports	Platform ladder 4 m
Duct orientation & shape	Vertical Circular
Downstream disturbance	Exit 0D
Upstream disturbance	Exit 0D
No. traverses & points sampled	2 8
Sample plane compliance to AS4323.1	Non-compliant

The sampling plane is deemed to be non-compliant due to the following reasons:

The downstream disturbance is <1D from the sampling plane

The upstream disturbance is <2D from the sampling plane

The stack or duct does not have the required number of access holes (ports)
