NARRABRI GAS PROJECT

Rehabilitation Management Plan

PHASE 1

0041-150-PLA-0001

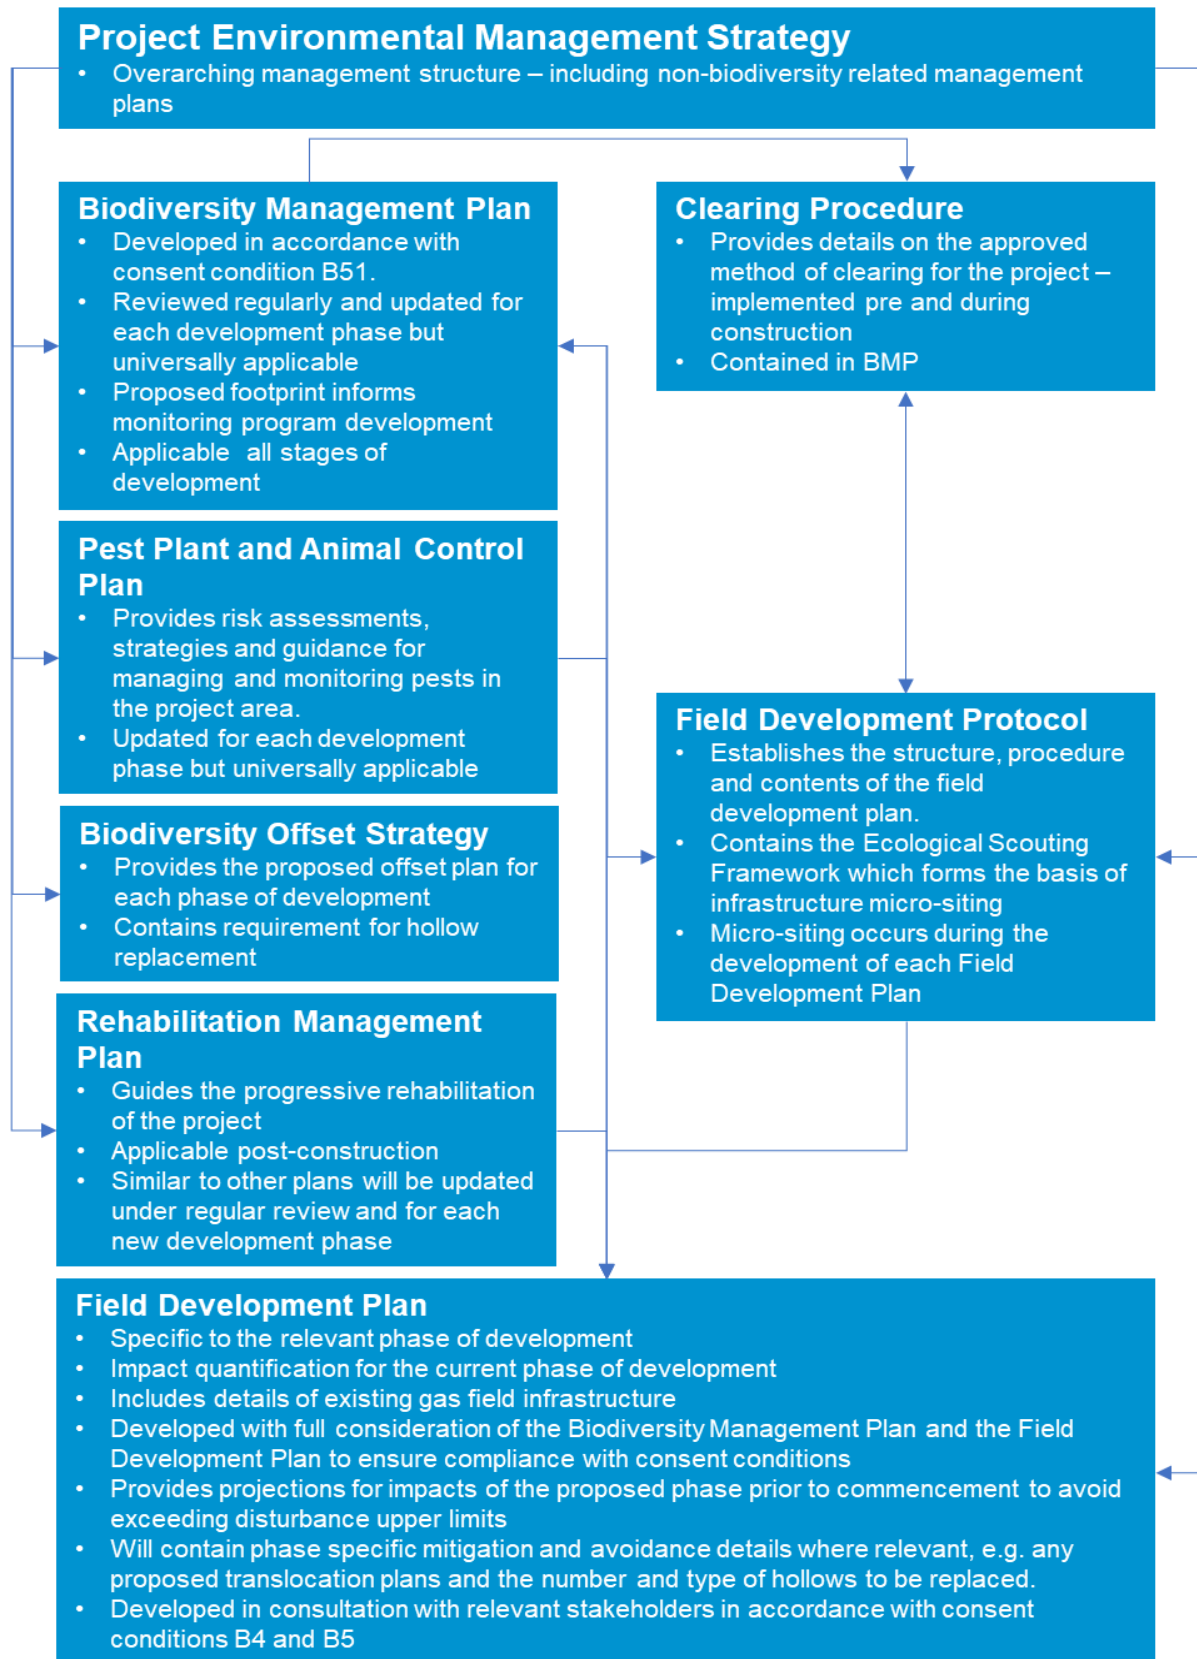
Figure 1.1 - Conceptual overview of management plan and field development integration

The RMP is a part of the project environmental management framework. The structure of the RMP, BMP and sub-plans, and other biodiversity-related management plans is intricately linked with the Field Development Protocol and Field Development Plan. The protocols and management plans provide a framework for the development of Field Development Plan. A conceptualisation of the interactions between these plans and the timing of application is provided below (Figure 1.1). Note that the full suite of management plans for the NGP is not shown. The complete management plan framework is presented in the EMS.

The RMP will be maintained throughout the life of the Project to ensure adaptive management principals are applied, including future updates to the Field Development Protocol and Field Development Plans prior to the commencement of Phase 2.

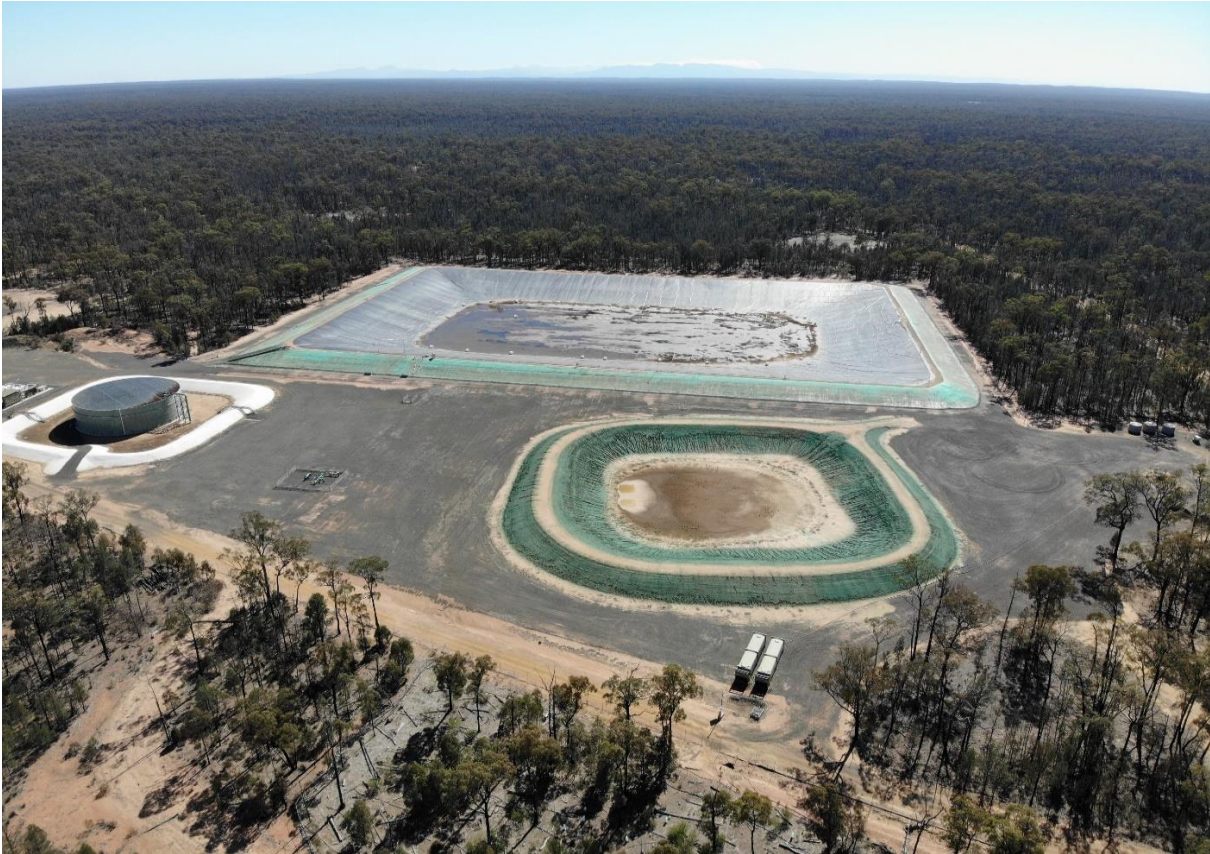
Figure 6.1 - Aerial view of infrastructure at Bibblewindi

Domain 3 includes the existing Leewood and Bibblewindi facilities and Bibblewindi to Leewood infrastructure corridor. For Phase 1, no additional infrastructure is proposed or approved at these sites, and they will continue current operations as follows:

- Leewood:
 - a central water management facility including storage and treatment of produced water
 - irrigation pivot and associated infrastructure
 - beneficial reuse of amended treated produced water for irrigation
 - storage, amenities and parking areas
- Bibblewindi:
 - gas compressor and associated safety flare
 - produced water balance tank
 - storage, amenities and parking areas
- Bibblewindi to Leewood infrastructure corridor:
 - gas and water pipeline within a 10 m wide corridor.

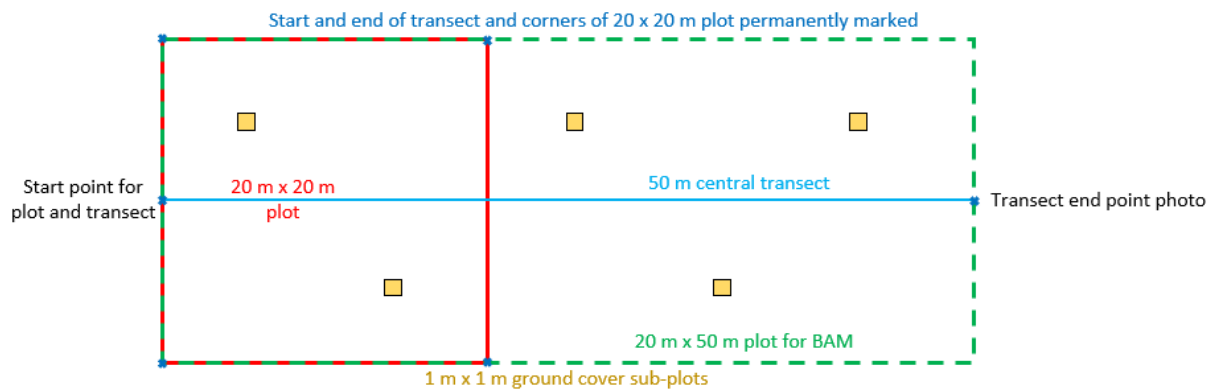
Figure 12.1 - Example of rehabilitation monitoring plot configuration

A standard monitoring plot design shown in Figure 12.1 with conceptual monitoring locations shown in Figure 12.2. The design includes:

- transect on contour, running through the centre of the plot.
- a minimum of three control and three impact sites per representative plant community type will be used to track the progress of rehabilitation during Phase 1.
- existing plot locations from previous flora surveys will be used where possible.
